# WOOD DESTROYING PESTS AND ORGANISMS INSPECTION REPORT

Building No. 1520	Street Oak Ave	City Fillmore, CA	Zip 93015	Date of Inspection 9/24/2008	Number of pages Page 1 of 6
----------------------	-------------------	----------------------	--------------	---------------------------------	--------------------------------

**Report # 1351**

A one and two story stucco frame residence with a tile roof unimproved underarea, and attached garage

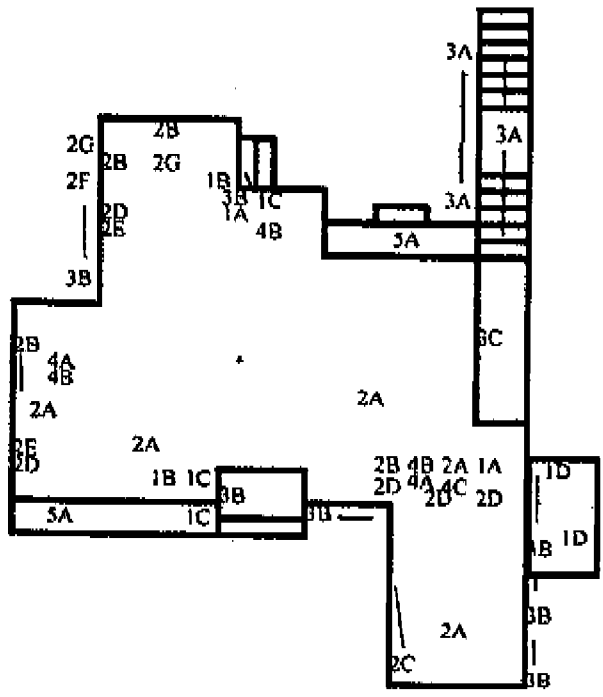
Finding: 1A Cellulose debris and evidence of subterranean termites found in the subarea as indicated on the diagram by 1A.

Finding: 1B Evidence of Subterranean termite found in the subarea as indicated on the diagram by 1B.

Finding: 1C Subterranean termite damage and dryrot damage found at the tile porch, stairs, plywood and framing as indicated on the diagram by 1C.

Subterranean termite damage and dryrot damage found at the screen porch enclosure as indicated on the diagram by 1D.

Evidence of drywood termites found in the attic as indicated on the diagram by 2A. Infestations appear to extend into inaccessible areas.

Evidence of drywood termites found interior as indicated on the diagram by 2B. Infestations appear to extend into inaccessible areas.

Evidence of drywood termites found in the garage as indicated on the diagram by 2C. Infestations appear to extend into inaccessible areas.

Drywood termite and and dryrot damage found at several windows as indicated on the diagram by 2D.

Finding: 2E Drywood termite and and dryrot damage found at the window sills and frames as indicated on the diagram by 2E.

Finding: 2F Drywood termite and and dryrot damage found at the door sills as indicated on the diagram by 2F.

Finding: 3A Moisture Leakage, fungus infection and dryrot damage found at the stairway, landing and handrail as indicated on the diagram by 3A.

Finding: 3B Fungus infection and dryrot damage found at the roof eave sheathing and rafters as indicated on the diagram by 3B.

Finding: 3C Fungus infection and dryrot damage found at the subfloor and framing below the porch leading into the house as indicated on the diagram by 3C.

Finding: 4A Moisture stains found at the subflooring below the bathrooms as indicated on the diagram by 4A.

Moisture stains found on the ceiling as indicated on the diagram by 4B.

Moisture stains found in the attic roof sheathing as indicated on the diagram by 4C.

Moisture stains found at the walls as indicated on the diagram by 4D.

The area below the porch and stairs was inaccessible for inspection due to lack of access as indicated on the diagram by 5A.

Recommendation: Remove cellulose debris and haul away from the premises. Treat the infested areas with Dagnet (Permethrin) or Premis (Imidacloprid) for the control of subterranean termites. Remove termite tubings in the accessible areas.

Recommendation: treat the infested areas of soil with Dagnet (Permethrin) or Premis (Imidacloprid) for the control of subterranean termites. Remove tubings in the accessible areas. **WARRANTY: One year to the area treated.**

Recommendation: Remove the tiles, the damaged plywood and framing. Replace with new material. Install proper moisture barrier and retille. **Note.THIS REPAIR WOULD BE COMPLETED ON A TIME AND MATERIALS BASIS.**

Remove damaged area and replace with new material, ready for painter.  
NOTE: If during the course of repairs, additional damage is found, work will cease and a Supplemental Report will be issued outlining findings, recommendations and costs.

Vacate and seal the structure. Fumigate with Vikane (Sulfuryl Flouride) and Chloropicrin (warning agent) for the extermination of drywood termites. Remove, seal and air out the building. Ready for occupancy. When possible, remove or cover accessible evidence. This company will not be liable for damage to plants, paint, roofs, T.V. Antennas. Fumigation cannot take place in strong winds or rain and will be rescheduled if there is inclement weather. Warranty: 2 years for drywood termites.

Remove windows and temporarily board up opening with plywood. Repair windows, ready for painter. If during the course of this repair the glass is broken, new glass will be installed at additional cost.

Recommendation: Remove damaged area and replace with new material, ready for painter.  
NOTE: If during the course of repairs, additional damage is found, work will cease and a Supplemental Report will be issued outlining findings, recommendations and costs.

Recommendation: Remove damaged area and replace with new material, ready for painter.

Recommendation: Remove the tile, remove the damaged framing and rebuild with new material. Install proper moisture barrier flashing and retiling and stucco. NOTE: THIS IS ONLY AN ESTIMATE, AND THIS REPAIR WOULD BE COMPLETED ON A TIME AND MATERIALS BASIS

Recommendation: Remove damaged area and replace with new material, ready for painter. After the completion of 3B, we recommend others to contact a licensed roof to inspect and make necessary corrections.

Recommendation: Any questions regarding this condition should be referred to a licensed contractor.

We recommend that others contact a licensed roofer to inspect and make necessary corrections.

Any questions regarding this condition should be referred to a licensed contractor.

Others to permit inspection. A Supplemental Report will be issued outlining findings, and additional costs.
