WOOD DESTROYING PESTS AND ORGANISMS INSPECTION REPORT

BUILDING NO. 944	STREET, CITY, STATE, ZIP Hargus Avenue, Vallejo CA 94591	Date of Inspection 1/15/2009	No. of Pages 7
Fungus Fighters Termite & Construction, Inc. 425 Couch Street, Vallejo, CA 94590 (707) 557-5093 • (510) 222-3955 Fax (707) 557-2551			
Firm Registration No. PR 3640		Report No. 4389	
Ordered By: Hightower Properties 261 Weathermark Court Vallejo, CA 94591 Attn: Thomas Hightower 694-0229 cell		Property Owner/Party of Interest Pritula	
Escrow No. _____ Report Sent To: _____			
COMPLETE REPORT <input checked="" type="checkbox"/> LIMITED REPORT <input type="checkbox"/> SUPPLEMENTAL REPORT <input type="checkbox"/> REINSPECTION REPORT <input type="checkbox"/>			
General Description: Two story rustic and stucco exterior residence		Inspection Tag Posted: Access 01/15/2009	
		Other Inspection Tags: None Noted	
An inspection has been made to the structure(s) shown on the diagram in accordance with the Structural Pest Control Act. Detached porches, detached steps, detached decks and any other structures not on the diagram were not inspected.

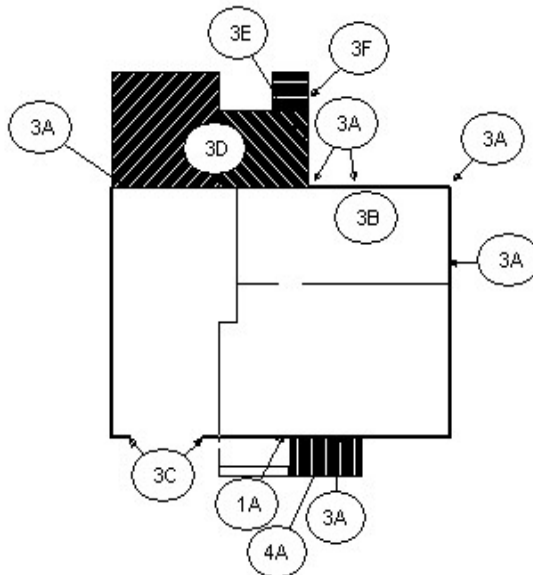
NOTE: DIAGRAM NOT TO SCALE

- ITEM 1A FINDING 1A: Old subterranean termite damage was noted to the downstairs door casing in this area. No active infestation was noted.
RECOMMENDATION: Replace the damaged door casing as needed. If not using pre-primed material, apply one coat of white primer to the new material. NOTE: No chemical treatment is needed at this time.
***** This is a Section 1 Item *****

- ITEM 3A FINDING 3A: Fungus damage was noted to the eaves, rafters and fascia boards in these areas.
RECOMMENDATION: Repair as necessary and apply one coat of white primer only. If a roof warranty is desired, we advise further inspection by a licensed roofer. *NOTE: REPAIRS AT THIS ITEM MAY DISTURB THE ROOF. IT IS THE OWNERS RESPONSIBILITY TO OBTAIN THE SERVICES OF A LICENSED ROOFER TO REPAIR THE ROOF COVERING AFTER COMPLETION OF THIS ITEM.* NOTE: During the course of repairs which opens walls or any other previously inaccessible and/or concealed areas, should any further damage or infestation be found, a supplemental report will issued. Any work completed in these areas would be at the owner's direction, and at an additional expense. NOTE: IT WILL BE NECESSARY TO REMOVE AND REINSTALL THE EXISTING GUTTERS IN THESE AREAS TO COMPLETE REPAIRS. IT IS THE OWNERS RESPONSIBILITY TO HAVE THE GUTTERS REMOVED AND REINSTALLED AFTER COMPLETION OF THE REPAIRS.

***** This is a Section 1 Item *****
- ITEM 3B FINDING 3B: Surface fungus was noted on the subfloor beneath the bathroom.
RECOMMENDATION: Scrape and treat the infected wood members with TIM-BOR, a registered fungicide, in accordance with the manufacturer's label.

***** This is a Section 1 Item *****
- ITEM 3C FINDING 3C: Fungus has damaged the upper and lower garage door jambs.
RECOMMENDATION: Remove the damaged upper and lower garage door jambs for further inspection. If no further damage is exposed, replace with new material. If not using pre-primed material, apply one coat of white primer only.

- ITEM 3D FINDING 3D: Fungus damage was noted to the decking and framing at the rear deck.
RECOMMENDATION: Replace the damaged wood members as needed. This estimate does not include any painting.
***** This is a Section 1 Item *****
- ITEM 3E FINDING 3E: Fungus damage was noted to the 4x4 post in this area.
RECOMMENDATION: Replace the damaged post as needed. This estimate does not include any painting.
***** This is a Section 1 Item *****
- ITEM 3F FINDING 3F: Fungus damage was noted to the step jack at the rear deck.
RECOMMENDATION: Replace the damaged step jack as needed. This estimate does not include any painting.
***** This is a Section 1 Item *****

- ITEM 4A FINDING 4A: Cellulose debris was noted beneath the front steps.
RECOMMENDATION: Remove the cellulose debris of a rakable size from beneath the front steps and dispose of.
***** This is a Section 2 Item *****
